## *SMART DENTAL UPDATES*

## The Unique Case of a Broken Periodontal Instrument Tip

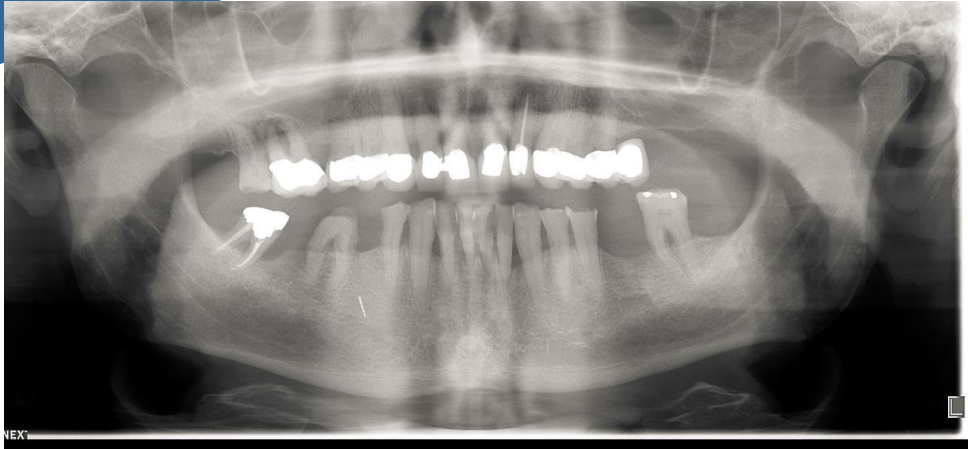
A 59-year-old patient came, for repair of a broken tooth in the maxillary left quadrant and clarification of therapy options for various other dental problems. On routine Orthopantomography (OPT), Region 45 showed a thin cylindrical, approximately 5 mm

(coronal-apical) metallically dense opacity in the OPT (Figure 1).

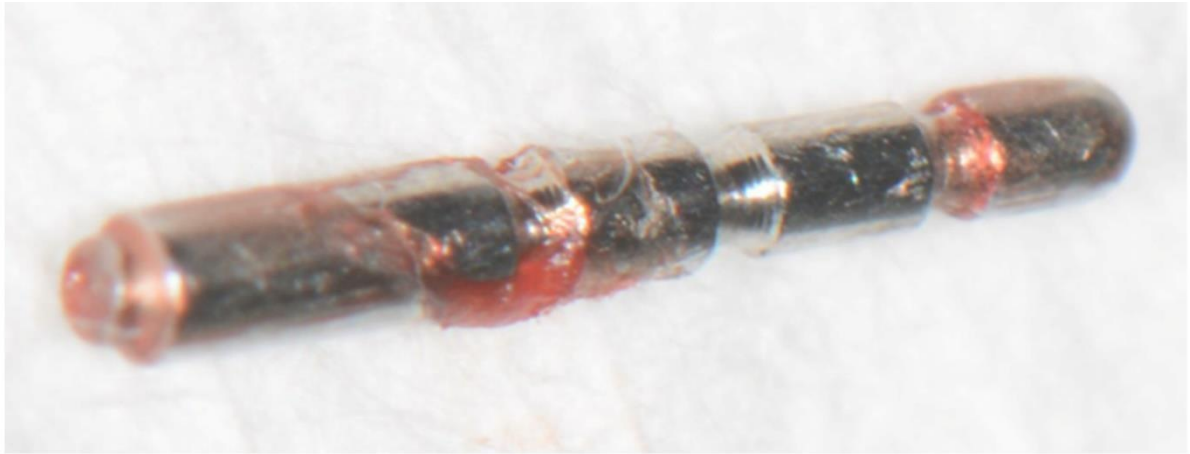
Fig. : The surgically removed fragment tip of a periodontal probe type AE P OWP.
